**FEDERAL AVIATION ADMINISTRATION
AIRWORTHINESS DIRECTIVES**

**SMALL AIRCRAFT, ROTORCRAFT, GLIDERS,
BALLOONS, & AIRSHIPS**

BIWEEKLY 2000-02

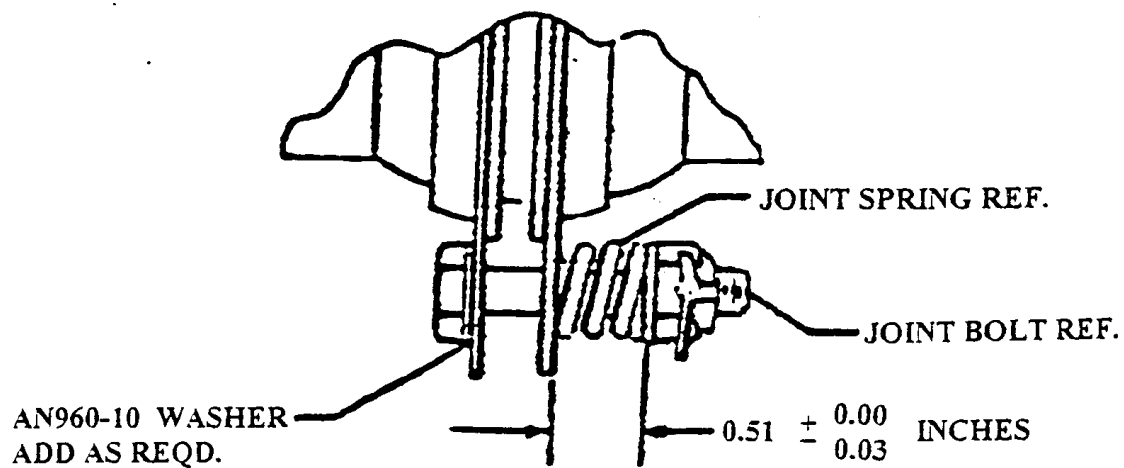
FIGURE 1 to the Appendix

- (3) Visually inspect the exhaust joint springs for correct compression. If the joint is disturbed or if the springs are obviously loose or frozen, proceed with the following inspection (see Figure 1 of this Appendix).

- (i) Before removal of the exhaust joint springs, measure the installed length of each spring, and replace the springs compressed to less than .45 inch.

- (ii) Remove all the springs and measure the free length. Replace any spring having a free length of less than .57 inch.

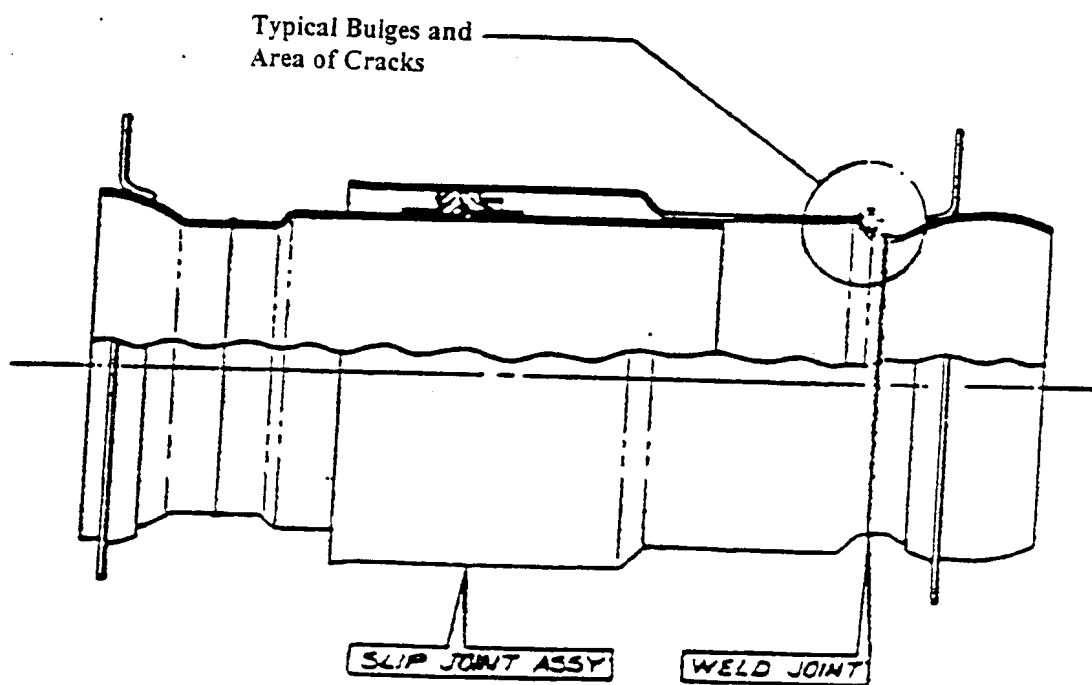
FIGURE 2 to the Appendix

- (4) If installed, visually inspect the slip joint(s) for bulges beyond the normal manufacturing irregularities of .03 inches and/or cracks. If any bulges and/or cracks are present, replace the bulged or cracked slip joint(s). (Refer to the appropriate Cessna Aircraft Service Manual) (See Figure 2 of this Appendix).

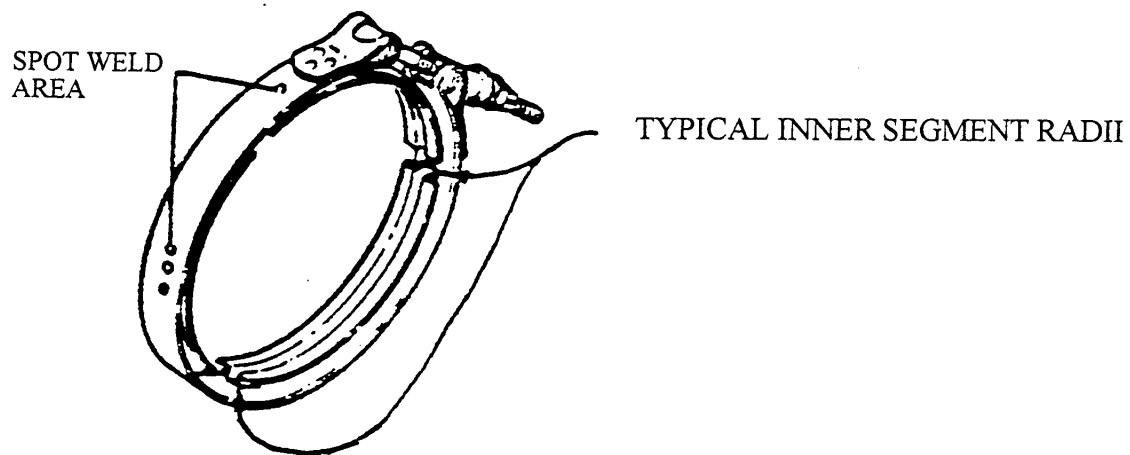
FIGURE 3 to the Appendix

- (i) Visually inspect the outer band in the area of the spot weld for cracks (see Figure 3 of this Appendix). If cracks are found, replace the clamp(s) with new multi-segment "V" band clamp(s).

- (ii) Visually inspect the corner radii of the clamp inner segments for cracks (see Figure 3 of this Appendix). This inspection requires careful use of artificial light and inspection mirrors.

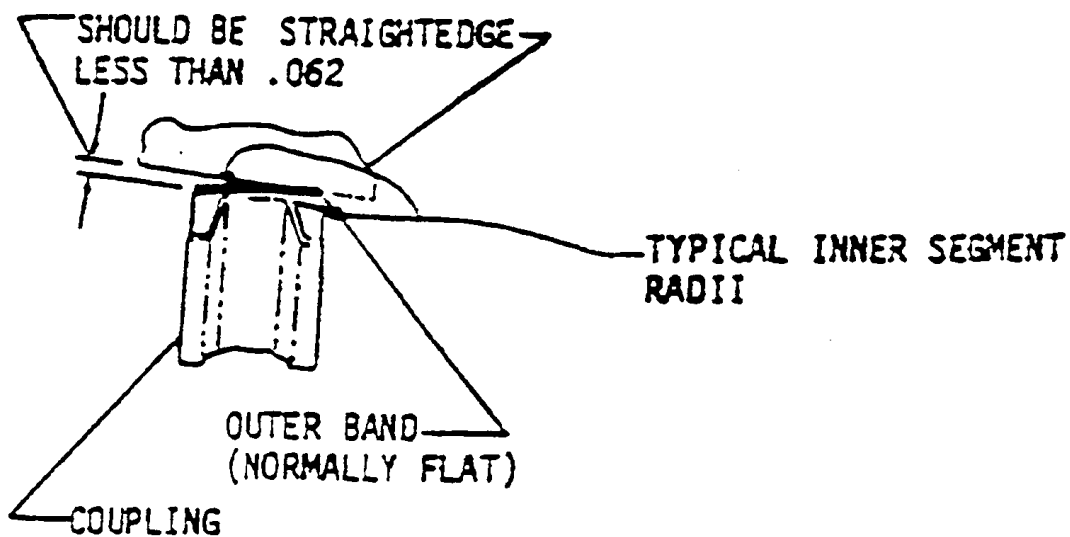
FIGURE 4 to the Appendix

- (iii) Visually inspect the flatness of the outer band, especially within 2 inches of the spot welded tabs that retain the T-bolt fastener. This can be done by placing a straight edge across the flat part of the outer band as shown in Figure 4 of this Appendix, then check the gap between the straight edge and the outer band. This gap should be less than 0.062 inch. If deformation exceeds the 0.062- inch limit, replace the clamp(s) with new multi-segment clamp(s). (See Figure 3 of this Appendix). See Cessna maintenance manual(s) and revisions for correct installation procedures.

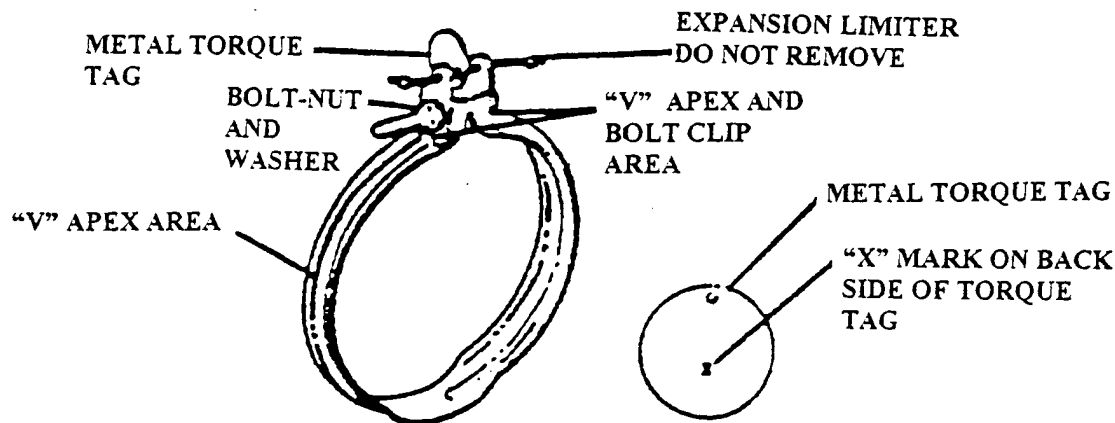
FIGURE 5 to the Appendix

- (iv) Visually inspect the one-piece "V" band clamp (overboard exhaust to turbocharger) with a light and mirror, in the area of the clamp surfaces adjacent to the intersection of the "V" apex and bolt clips, and the entire length of the "V" apex of the clamp for signs of cracks or fractures. If cracks or fractures are visible, replace the clamp (see Figure 5 of this Appendix). See Cessna service manual(s) and revisions for correct installation procedures
